Field Report for Airborne Data Collected In Support of US EPA Region 6 Intercontinental Terminals Company LLC Fire 22 March 2019

Data Results Flight 6 7, 8 and 9 22 March 2019

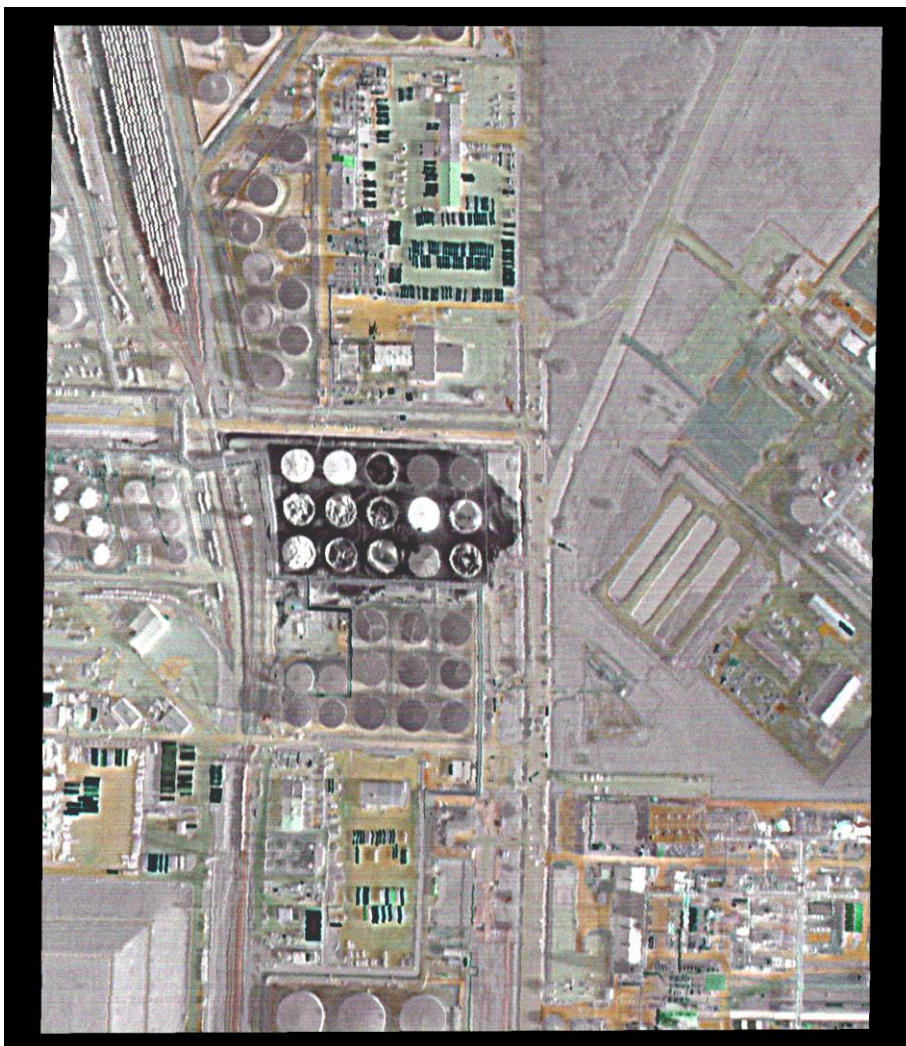
A total of 4 test and 17 data passes were made in the proximity of the impacted tank farm and also in extended areas surrounding the site and infrared line scanner images were generated for each pass. Figure 3 shows a typical 3-band infrared image obtained from data collected for Run 5. Examination of the IR image shows the tank farm with a black color within the secondary containment. This is actually white foam which is cooler than the surrounding oil and environment. A thermal analysis was conducted on a similar image with the results given in Figure 4 and tends to show that the tanks on the western end are actually the hottest with the NW tank consistently showing an elevated temperature remotely estimated to be about 70°C.

Figure 3: IR image of ITC data for 22 March 2019, Flight 7 Run 3

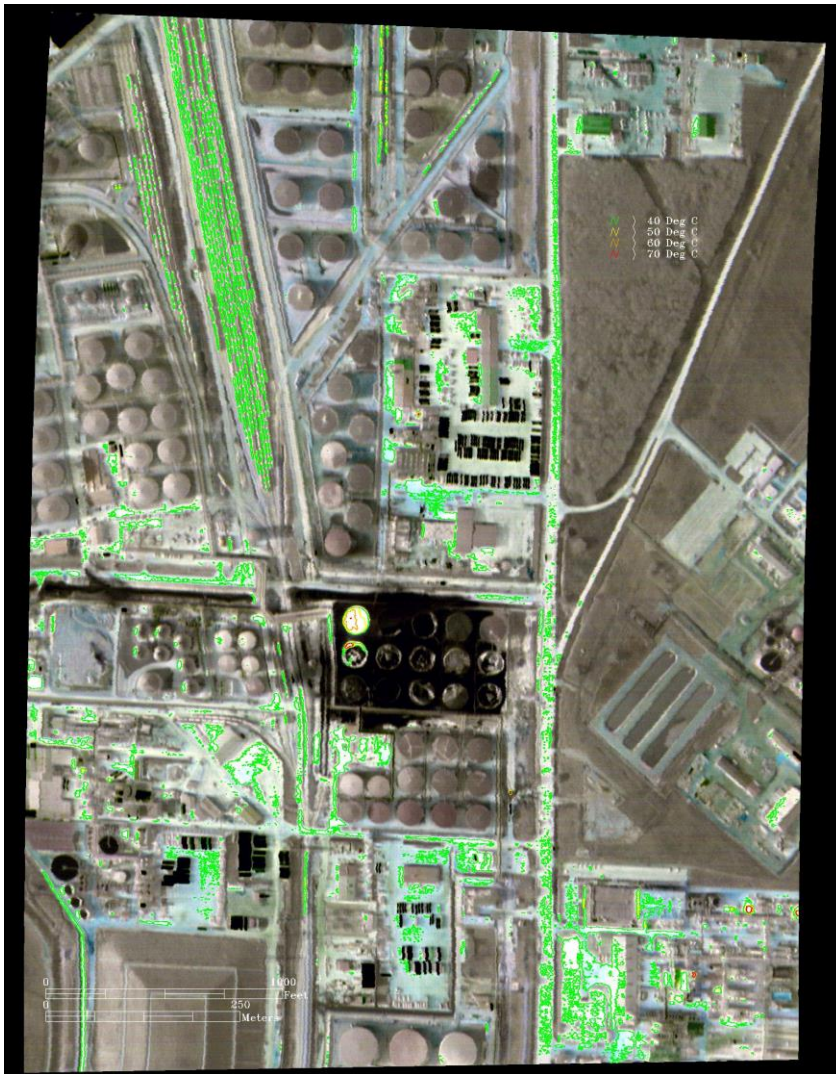
Figure 4: IR Thermal Analysis 22 March 2019, Flight 9, Run 3

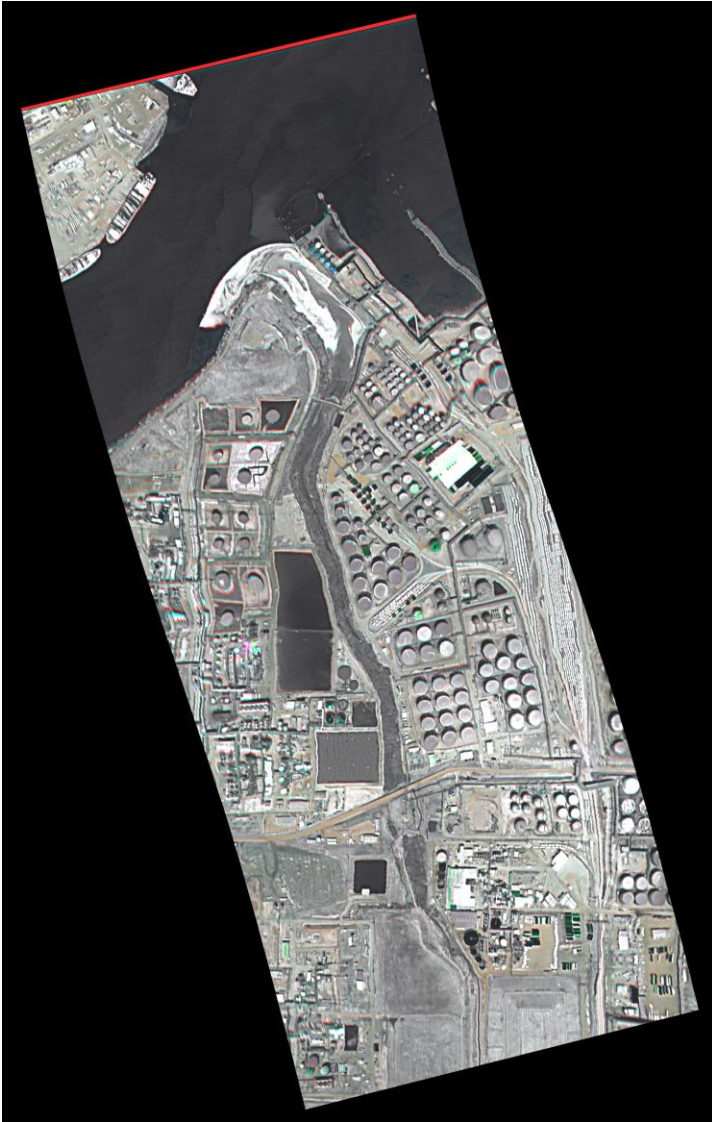
Fights 8 and 9 were prompted by a report that secondary containment had failed at the tank farm. Figure 5 shows an image collected along the drainage channel leading the ship channel. A white signature substance can be seen being trapped at the confluence of

the drainage channel. Again the image is effectively showing a thermal signature so the while color is warmer than the black which is cooler; the oil is trapping solar radiation and heating up while the foam is reflective and cooler. Further analysis of the image shows that some material is leaking past the boom and entering the ship channel.

Figure 5: IR Image 22 March 2019, Flight 8, Run 5

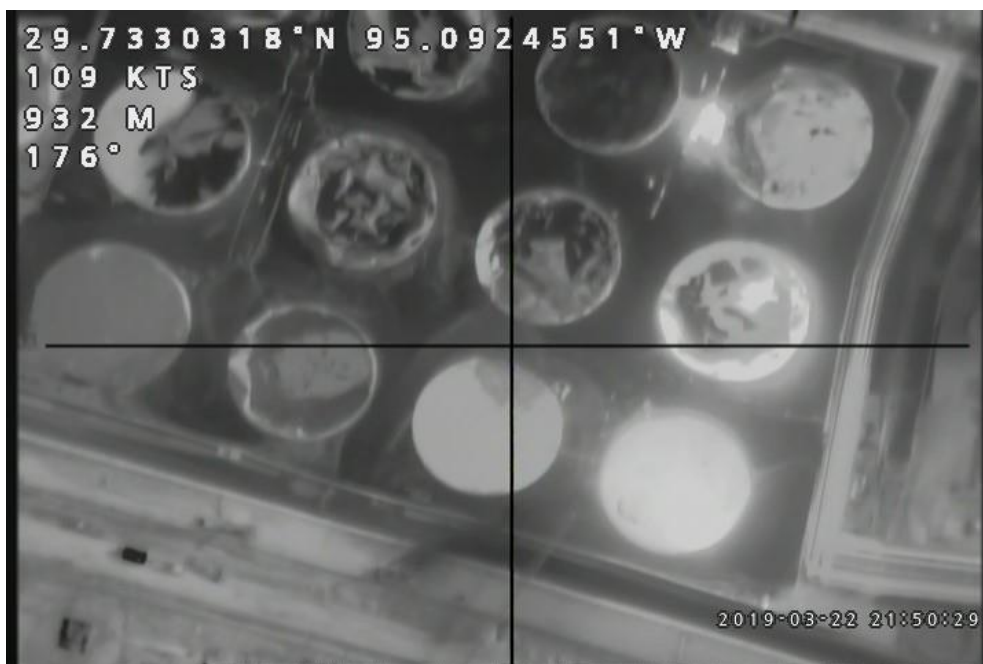
While the system was collecting data associated with the containment breach, a report was given that a fire restarted in the tank farm. Figure 6 is an example of IR imagery developed with the ASPECT night-vision thermal camera. Although this image is not calibrated, the content does show agreement with the thermal analysis conducted with data collected with line scanner. The image (which is flipped in direction) is showing the NW tank hotter than the surrounding but also is showing the tank south is hot around the edges and that a hot object is located further south and between the tanks.

Figure 6: Night Vision image 22 March 2019, Fight 9, Run 8

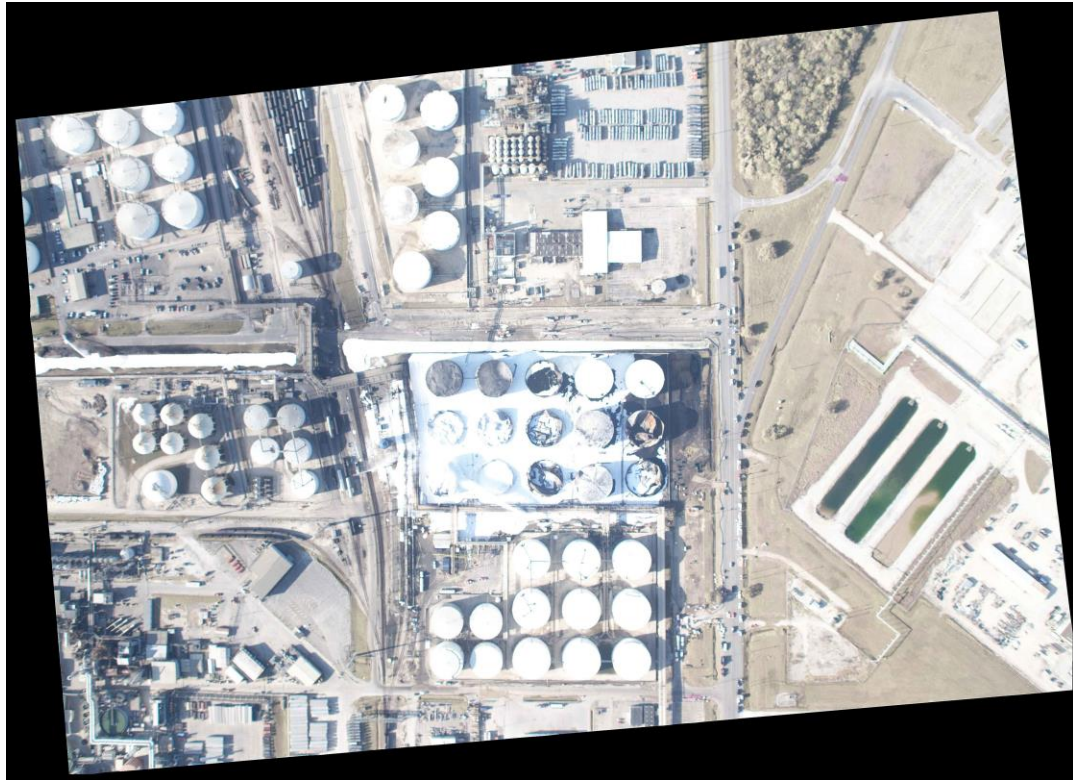
A full set of high resolution aerial digital photography was collected as part of the flight. Figure 8 shows a representative overhead image collected as part of each pass over the tank farm. Evident in this image is the white material in the drainage ditch located on the north side of the secondary containment. This does suggest that the containment structure may have been compromised. Figure 9 shows an oblique image of the tank farm and the fire that reignited. Note that the top of the image is toward the south. The location of the fire is generally consistent with IR thermal and night vision analysis described in the above section.

Figure 8: Aerial Image of the ITC Tank Farm, Flight 9

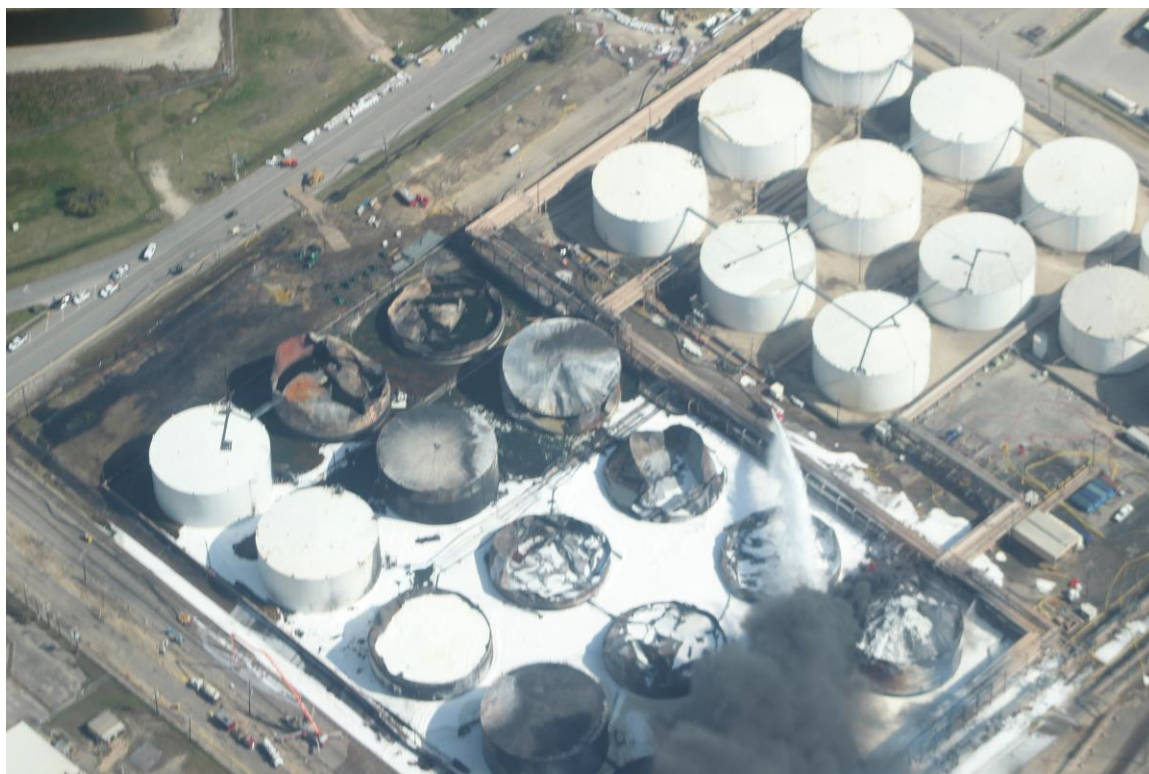
Figure 9: Oblique Image of the ITC Tank Farm, Flight 5
